Manhole Inspection Summary

Manhole # S29CC2006MH

Inspection ☐ Is Incomplete Rating: **3) Fair**

Location Address: **5 TAMWORTH RD**

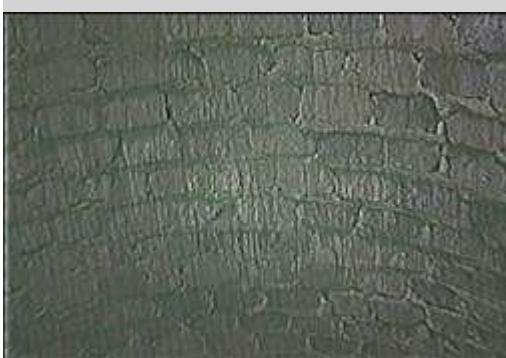
Defect

Bench and Channel debris.

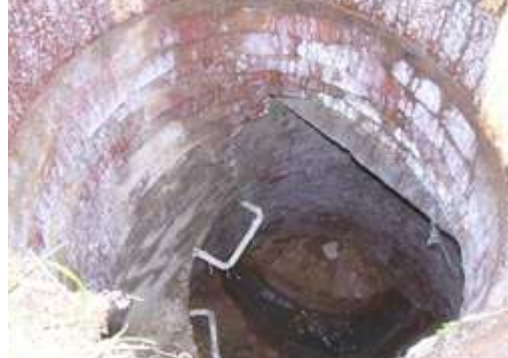
Defect

Condition: ☐ Sound ☐ Cracked ☐ Root Intrusion ☐ Loose Brick ☒ **Deteriorated**

Infiltration: ☐ None ☐ Joint ☐ Cracks ☒ **Mortar** ☐ Roots ☐ Wall

Barrel deterioration and infiltration.

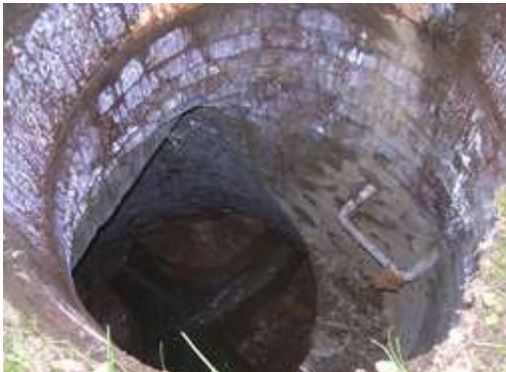
Defect

Infiltration: ☐ None ☒ **Joint** ☐ Cracks ☒ **Mortar** ☐ Roots ☒ **Wall**

Infiltration: ☐ None ☐ Joint ☐ Cracks ☒ **Mortar** ☐ Roots ☒ **Wall**

Adjustment, Corbel and Barrel infiltration.

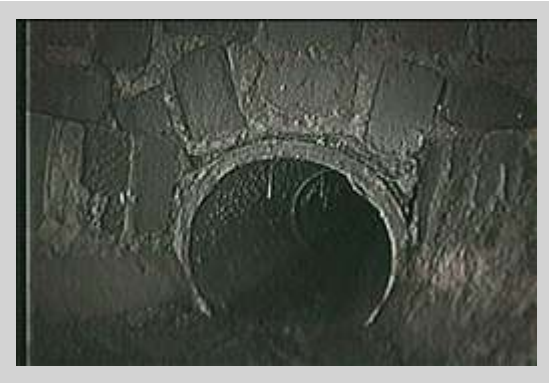
8 in. Circular Gravity Sewer Pipe Out @ 12 O'Clock

Infiltration: **Evidence** Pipe Seal Cond: **Unknown**

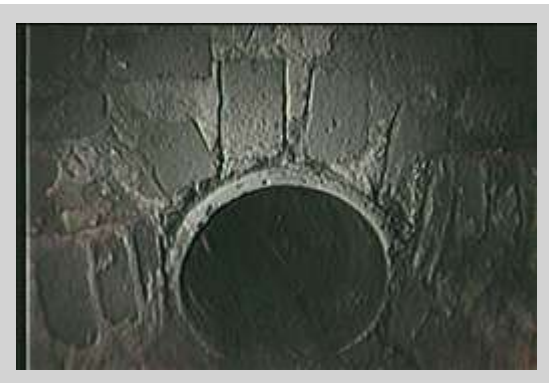
8 in. Circular Gravity Sewer Pipe In @ 3 O'Clock

Infiltration: **Evidence** Pipe Seal Cond: **Unknown**

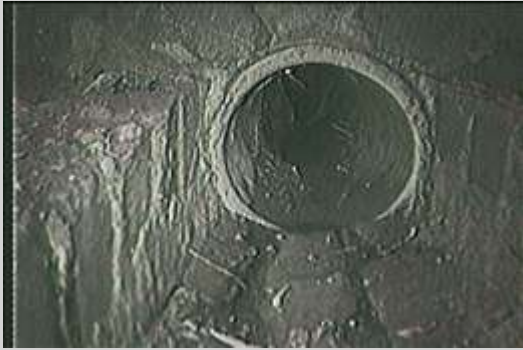
Pipe In @ 7 O'Clock

Infiltration: **Evidence** Pipe Seal Cond: **Cracked**

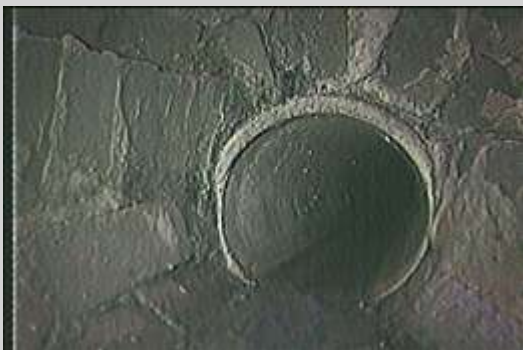
Pipe In @ 9 O'Clock

Infiltration: **Evidence** Pipe Seal Cond: **Cracked**
